Manhole Inspection Summary

Manhole # S39Q__019MH

Record Plat: **39Q** Node: **019** Status: **New Manhole (Not in GIS)** Insp Date: **9/16/08 12:00 AM**

Location Address: **1244 harbor island walk**

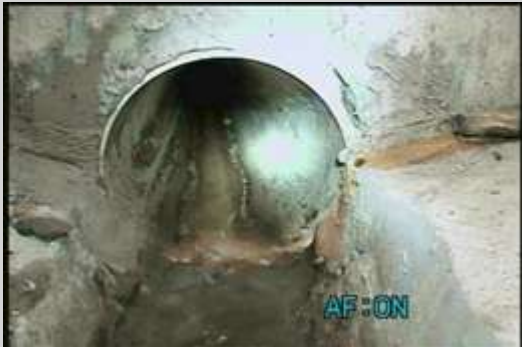
12 O'Clock Outflow

8 in. Circular Gravity Sewer
Pipe Out @ 12 O'Clock

Invert Depth: **6.50** (ft.) Flow Characteristics: **Slow**

Deposits: ☒ None ☐ Mud ☐ Sludge ☐ **Debris** ☐ Grease

Infiltration: **None** Pipe Seal Cond: **Unknown**

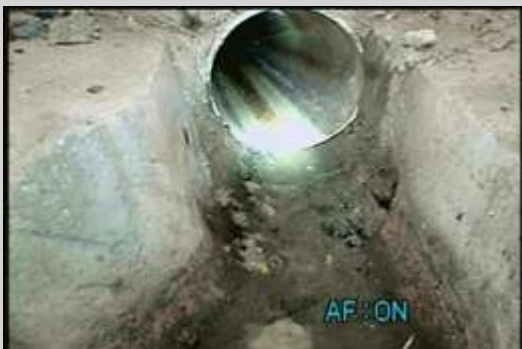
3 O'Clock Inflow

6 in. Circular Gravity Sewer
Pipe In @ 3 O'Clock

Invert Depth: **6.33** (ft.) Flow Characteristics: **None**

Deposits: ☒ None ☐ Mud ☐ Sludge ☐ **Debris** ☐ Grease

Infiltration: **None** Pipe Seal Cond: **Unknown**

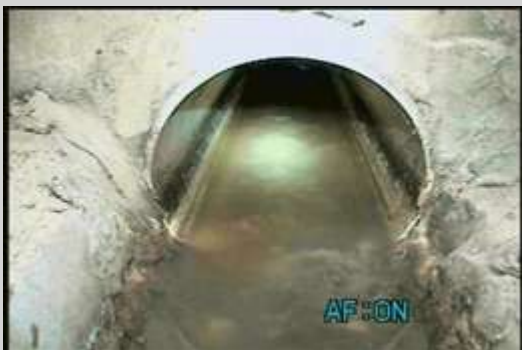
7 O'Clock Inflow

6 in. Circular Gravity Sewer

Pipe In @ 7 O'Clock

Infiltration: **None**
